**USAAVLABS TECHNICAL REPORT 66-32**

**FULL-SCALE DYNAMIC CRASH TEST OF  
A SMALL OBSERVATION TYPE HELICOPTER**

**May 1966**

**U. S. ARMY AVIATION MATERIEL LABORATORIES  
FORT EUSTIS, VIRGINIA**

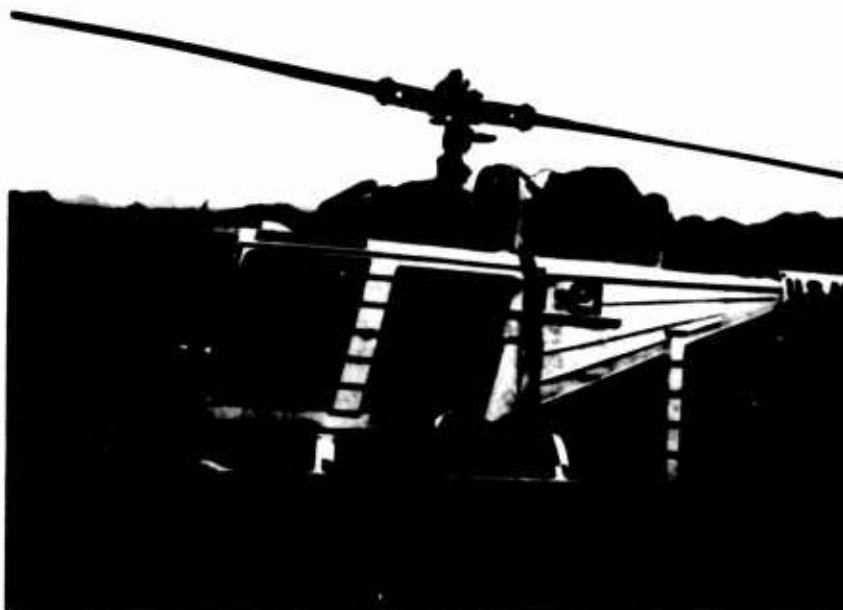
Figure 12 is a postcrash view of the left side of the aircraft. (Note that the forward end of the fuselage is still inclined in a slightly nose-up attitude). With the exception of the deformation of the skid cross members, very little structural deformation occurred. Some slight buckling resulted in the tail boom section directly above the rear skid cross member. Slight deformation and bending also occurred at the engine and transmission support attachments.

Figure 12. Postcrash View of the T-21 Aircraft (Left Side).  
Note the slight nose-up attitude.

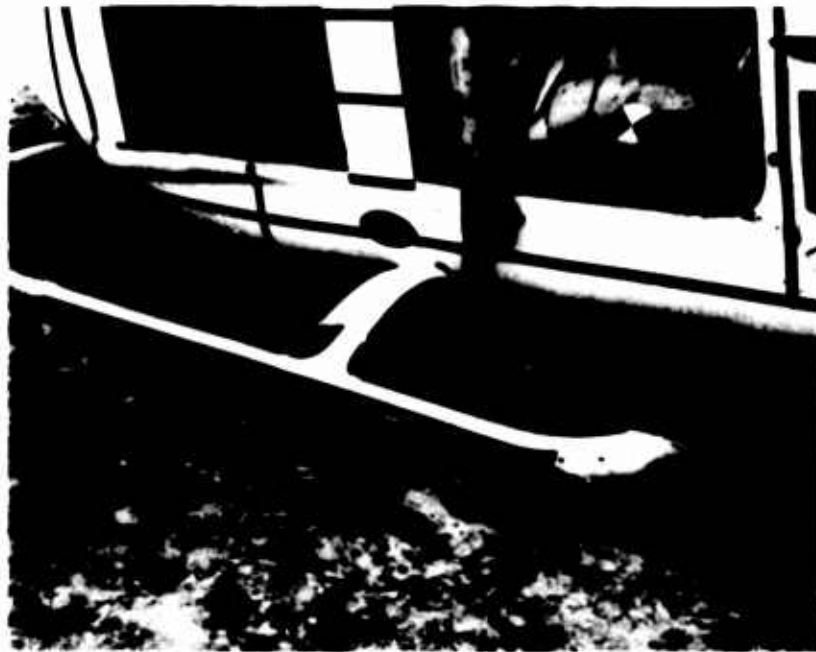
Figure 13 is a close-up view of the right side of the aircraft, showing the deformed skid cross member directly below the pilot's seat. Figure 14 is a postcrash rear view of the aircraft, showing the manner in which the skid cross members deformed at impact. Figure 15 is a postcrash front view of the aircraft.

Figure 13. Right Side Postcrash View of T-21 Aircraft, Showing Deformed Forward Skid Cross Member.

The test indicates that the OH-4A landing gear will attenuate a sinking speed of approximately 15 feet per second. The tapered-wall cross tube used in the gear is a good concept, and the gear performed approximately as intended. Improvements are possible, however, and the present state of the art should permit the design of gears which would allow sinking speeds of 20-25 feet per second for small aircraft without transmitting excessive acceleration forces to the occupants. Such a design would require an effective average deceleration of 8-10G over a distance of about 1 foot. Although the OH-4A gear placed a maximum load of 8G on the helicopter, this load was not maintained constant throughout the 1 foot of travel, indicating failure of the gear to completely utilize the available deceleration distance.
